# Manhole Inspection Summary

Manhole # S31O\_\_009MH

Insp Date: **9/17/08 8:54 AM**

**Location** Address: **oriole parking lot under highway**

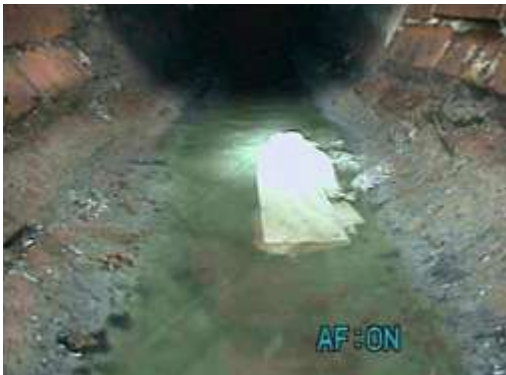
misc

channel debris

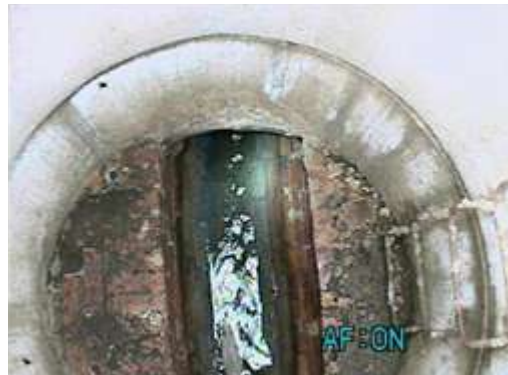
misc

bench debris

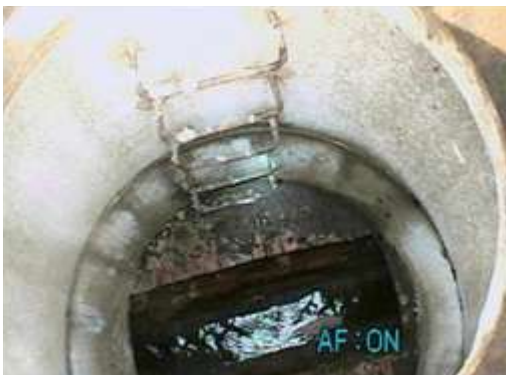
Defect 1

Infiltration: ☐ None ☒ **Joint** ☐ Cracks ☐ Mortar ☐ Roots ☐ Wall

Count: **5** Missing: **0** ☒ **Corroded**

infiltration at corbel/barrel joint, corroded steps

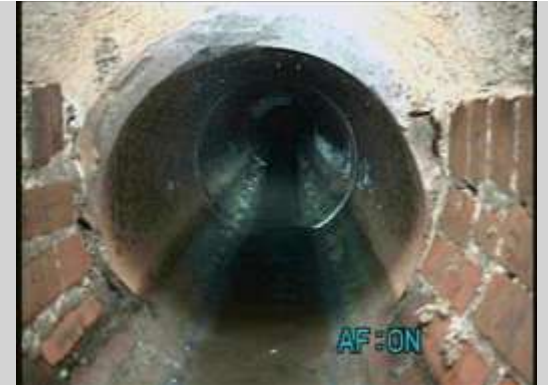
12 O'Clock Outflow

18 in. Circular Gravity Sewer  
Pipe Out @ 12 O'Clock

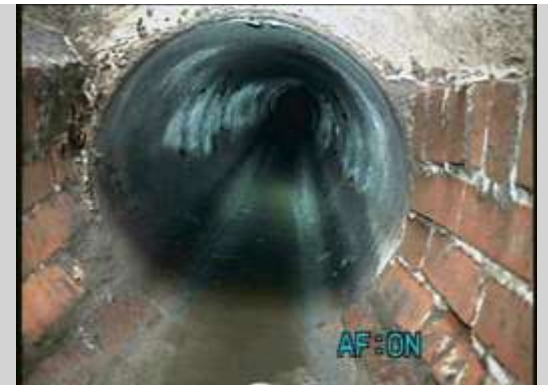
6 O'Clock Inflow

18 in. Circular Gravity Sewer  
Pipe In @ 6 O'Clock
